PENN LAKE DAM ASSESSMENT

Evaluation of Existing Deficiencies and Rehabilitation/Replacement Alternatives

Prepared for:
Penn Lake Park Borough
Luzerne County, Pennsylvania

Project Number: 2020-4778-002

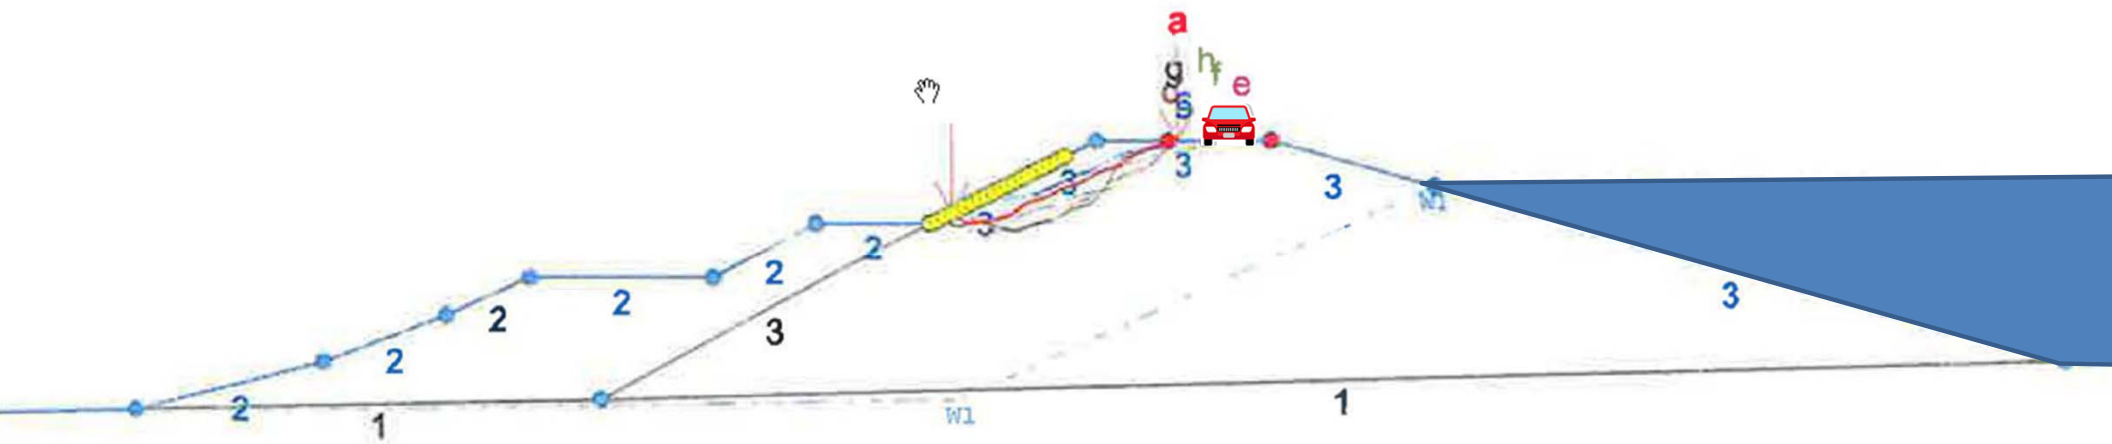
Existing Embankment Section

In addition to the inoperable control valve, the ductile iron conduit through the embankment is 115 years old with the exception of the extension installed in 1985 at the time the existing rock stability berm was constructed. The conduit was last video inspected in 2003 and found to be 95% covered in rust blisters; no joints could be identified through the rust.
