# Welcome to the Third Annual Public Meeting

Penn Lake Dam & Spillway Improvement Project

#### New Developments with Penn Lake Dam and Spillway Improvement Project Updated October 1, 2022

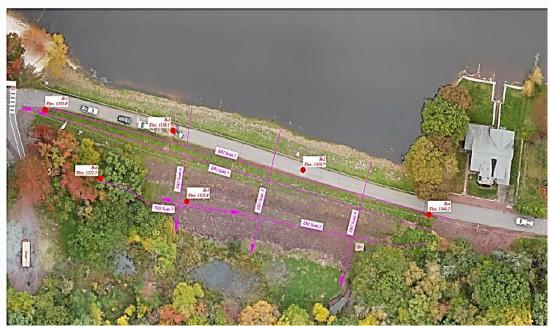
### **Geotechnical Evaluation of Existing Dam**

#### **Work Completed**

Electric Resistivity Imaging (7 scans) in September 2021.

Geotechnical Drilling in October 2021 to complete 4 borings along the crest of embankment.

Geotechnical Drilling in December 2021 to complete 2 additional borings.

#### CONCLUSIONS

Embankment stable under normal pool and earthquake conditions

embankment **NOT** stable under dam **overtopping** conditions

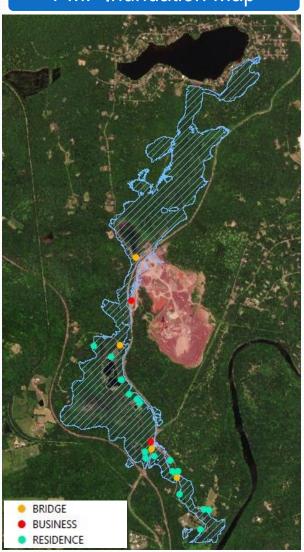
#### **Impacts Assessment**

Impact is anticipated to downstream structures and residential properties.
